REPORT DOCUMENTATION PAGE		READ INSTRUCTIONS BEFORE COMPLETING FORM
1. REPORT NUMBER	2. GOVT ACCESSION NO.	3. RECIPIENT'S CATALOG NUMBER
	AD-A092	296
4. TITLE (and Subtitle) Phase I Inspection Report Patterson Brixus Grey Creek Watershed Project, Site I Susquehanna River Basin, Broome County, New York Inventory No. 698		5. TYPE OF REPORT & PERIOD COVERED Phase I Inspection Report National Dam Safety Program

19. KEY WORDS (Continue on reverse side if necessary and identify by block number) Dam Safety National Dam Safety Program Visual Inspection Hydrology, Structural Stability Patterson Brixus Creek Watershed Project, Site I Broome County Patterson Creek

Photo #1
Overview of Patterson Brixius Site 1 Dam

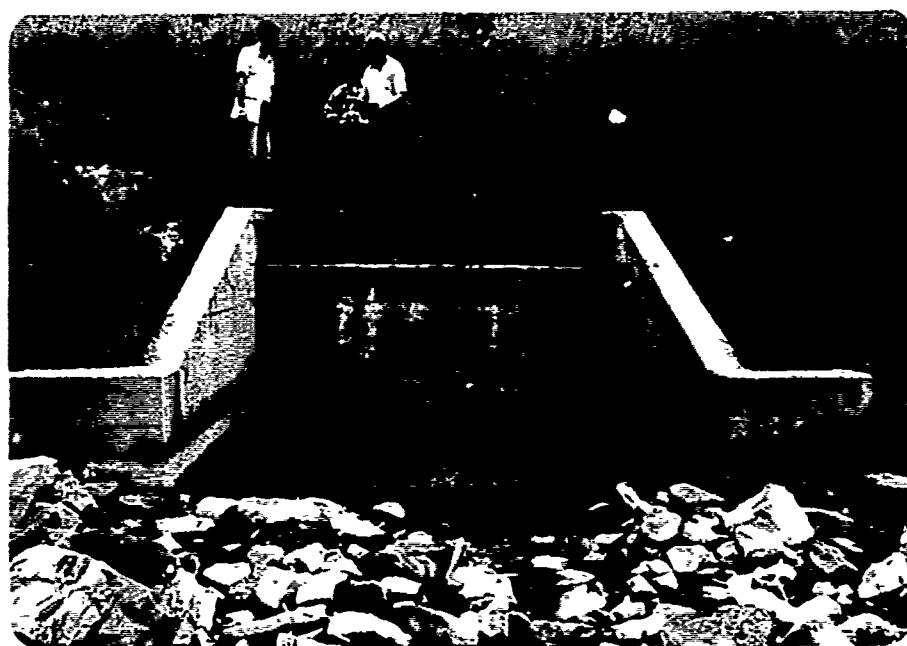
Photo #3
Impact Basin

An internal drainage system composed of 2 - 8 inch diameter pipes surrounded by "drain fill" and extending parallel to the axis of the dam, provides drainage at the embankment-subgrade contact. These pipes exit through the concrete walls of the impact basin. Discharge from these pipes was 1 to 2 gpm each. The flow was clear. The animal guard on the left pipe was broken. (See Photo #3)

The service spillway is generally in good condition. The maximum joint extension of the pipe is 0.5 inches. The joint between the pipe and the impact basin is open. The walls of the impact basin are slightly deteriorated. Calcification was noted from a crack or cold joint on the upstream wall about 1 foot above and to the right of the pipe. This area was dry at the time of the inspection.

4. Recaulk the joint between the service spillway pipe and the wall of the impact basin.
5. The walls of the impact basin are slightly deteriorated and the left animal guard is broken. Repair the concrete surfaces of the impact basin and the animal guard.

3. Recaulk the joint between the service spillway pipe and the impact basin wall. Repair the concrete surfaces of the impact basin, and repair the left animal guard.

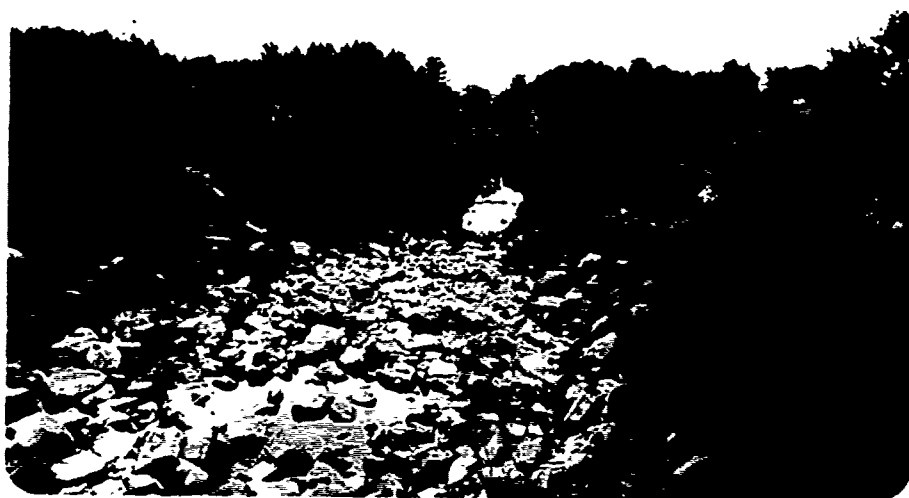
Photo #4
Downstream Channel

The downstream channel below the impact basin is riprapped. Some vegetation was observed along the banks of this channel. (Photo #4)
